Application Notes Mini Case Studies from the Field

#### Non-intrusive Temp. Measurement for Cheese Manufacturing

#### Case A080409

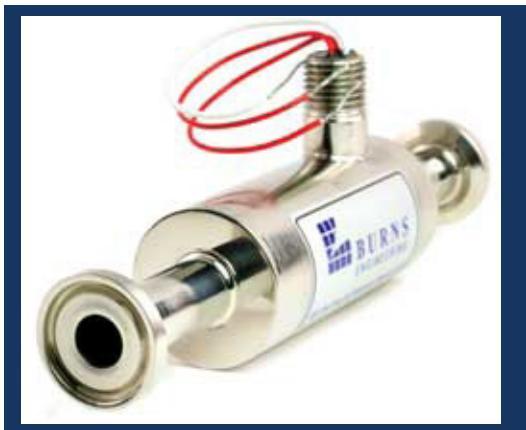
**SNI Non-intrusive Temp Sensor**

The Sanitary Non-intrusive Temperature Sensor is a surface sensor mounted on the outside of the process tube and surrounded by a protective concentric tube which thermal isolates the sensing element from the surrounding ambient air.

The SNI is mounted in line with the process and the process fluid flows freely through the tube. Since there is no probe in the process line, there is nothing to fail. The concentric housing creates a clean and sanitary thermal barrier. Time response performance can be similar to a direct immersion probe.
